USACERL Technical Report FM-93/08
September 1993
Advanced Paint Stripping

Evaluation of Vacuum Blasting and Heat Guns as Methods for Abating Lead-based Paint on Buildings

by
Jan W. Gooch
Susan A. Drozdz

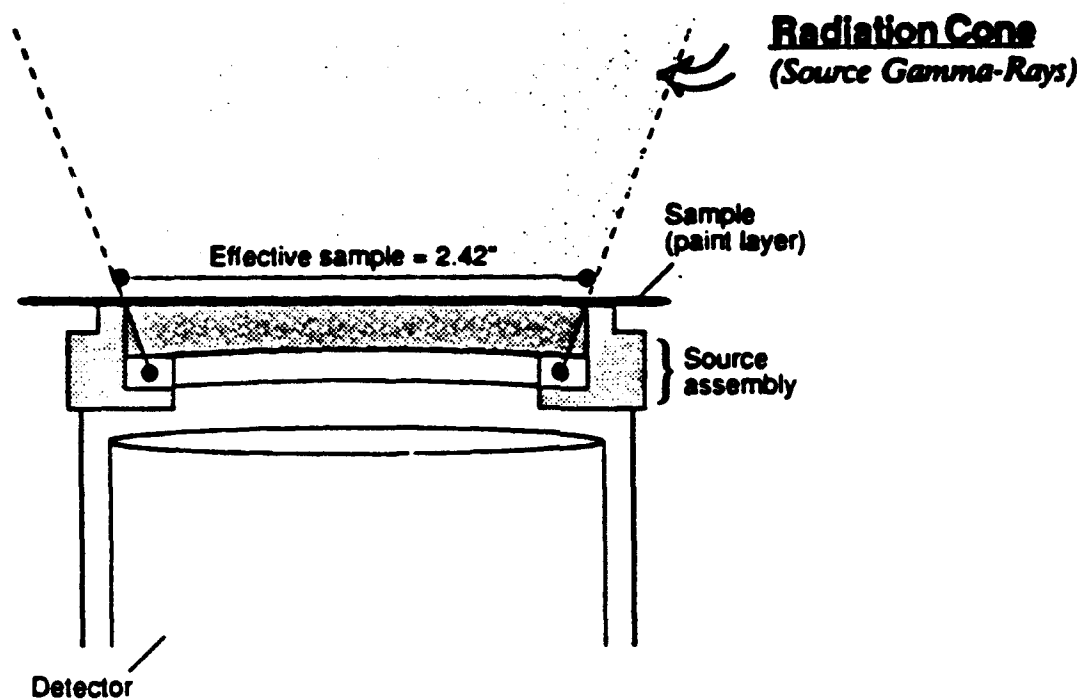
Figure 1. XRF Measurement of Flat Surface With XRF Head in Contact With Paint Sample.

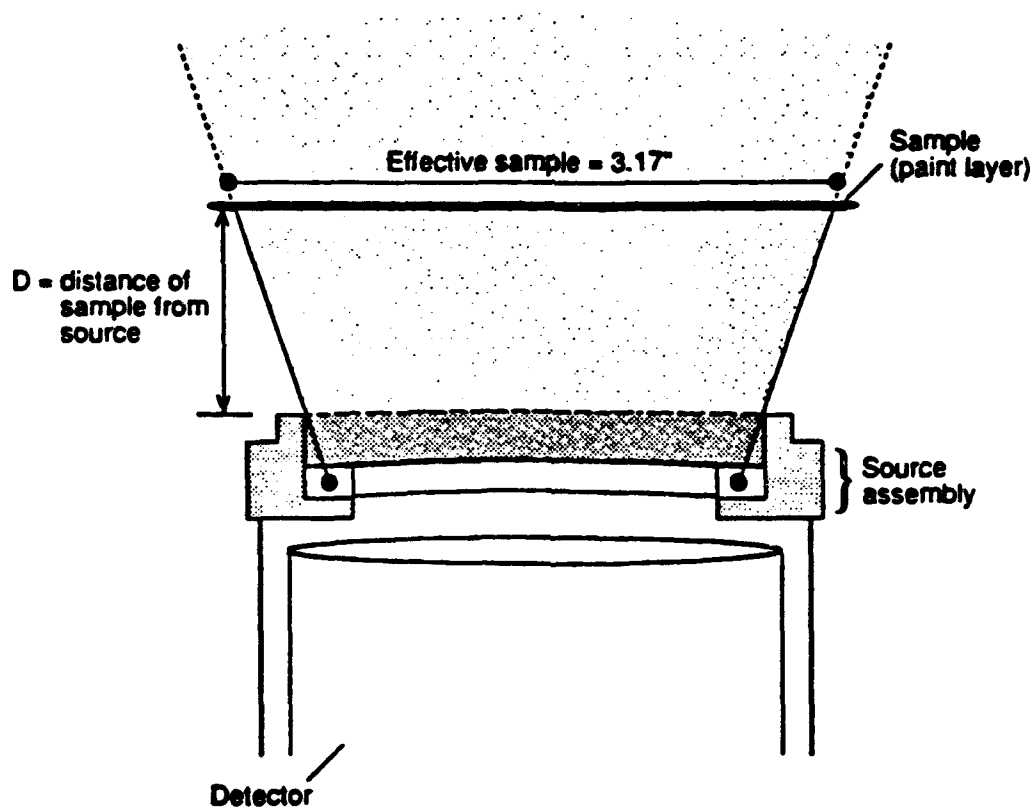
Figure 2. XRF Head at a Distance From Paint Sample.

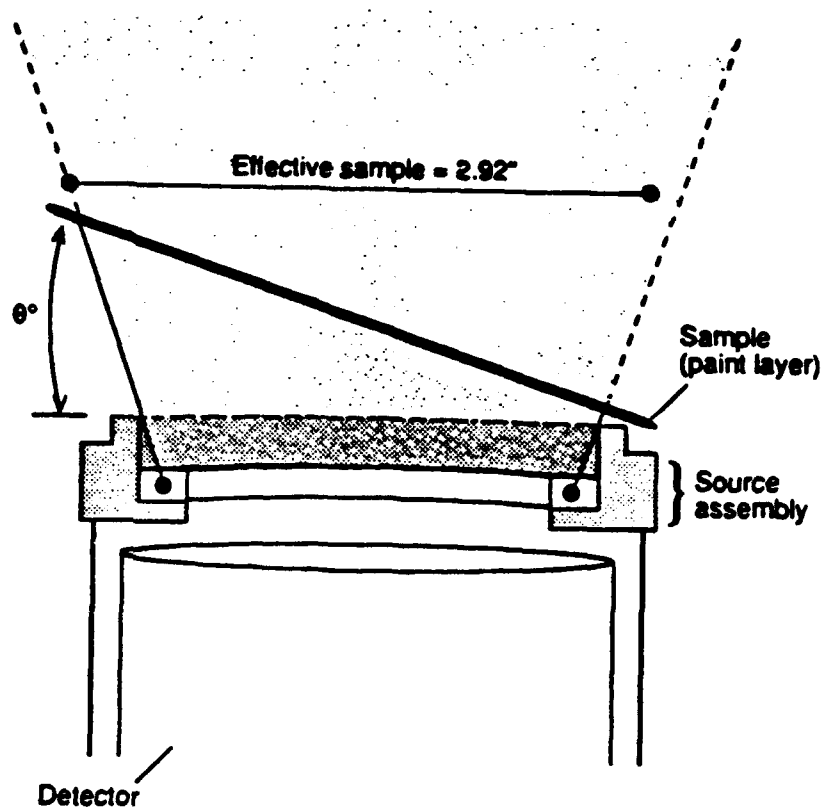
Figure 3. XRF Measurement of Window Lintel.

It matters which of the two competing phenomena is the most dominant. In the case of door lintel, most of the lintel's width is covered by the door frame. The portion of the lintel accessible for LBP testing dictates a geometry as conceptually depicted in Figure 4, where the painted surface does not intercept the entire source radiation cone. In fact, most of the radioactive source activity is missing the bulk of the tested surface and it is expected that the multiplication correction factor must be larger than in the window lintel measurements.

It was determined that the XRF system (for reasons of size of source and detector assembly) underestimates the presence of lead in the cases of door and window lintels, and backrail ties. For these cases the correction factors (CF) are:

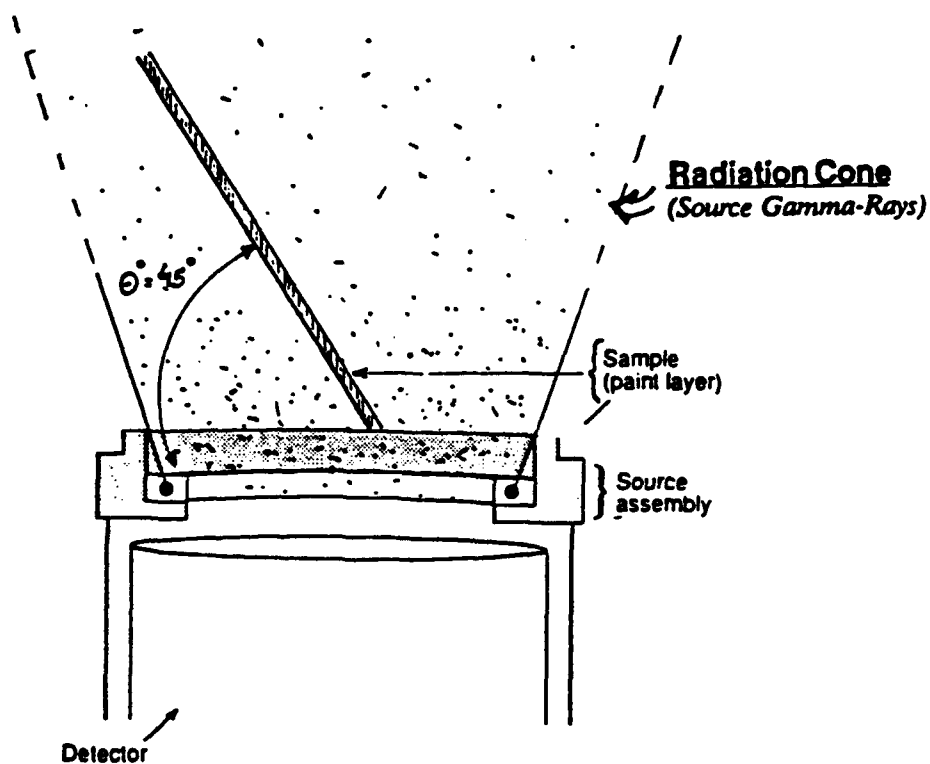
Figure 4. XRF Measurement of Door Lintel.

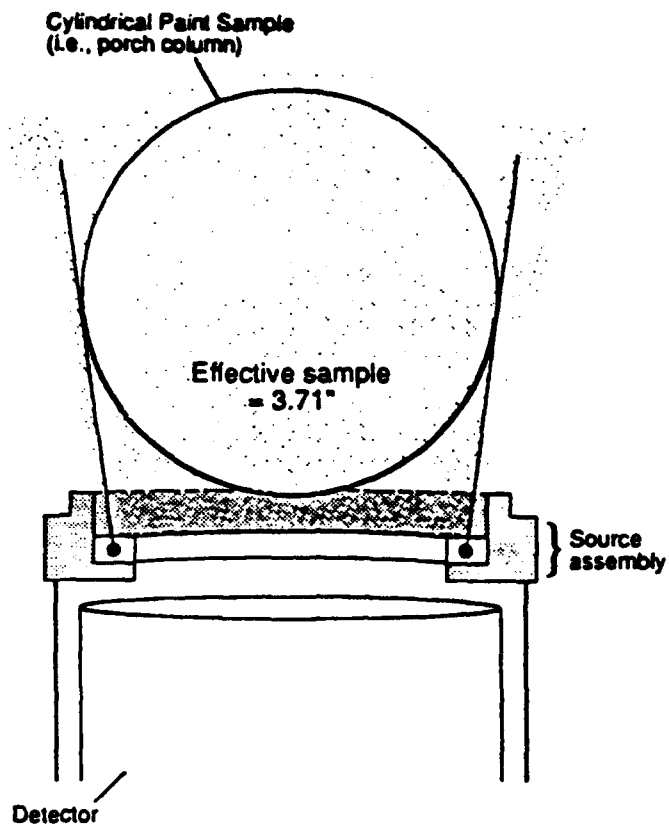
Figure 5. XRF Measurement of Porch Column.

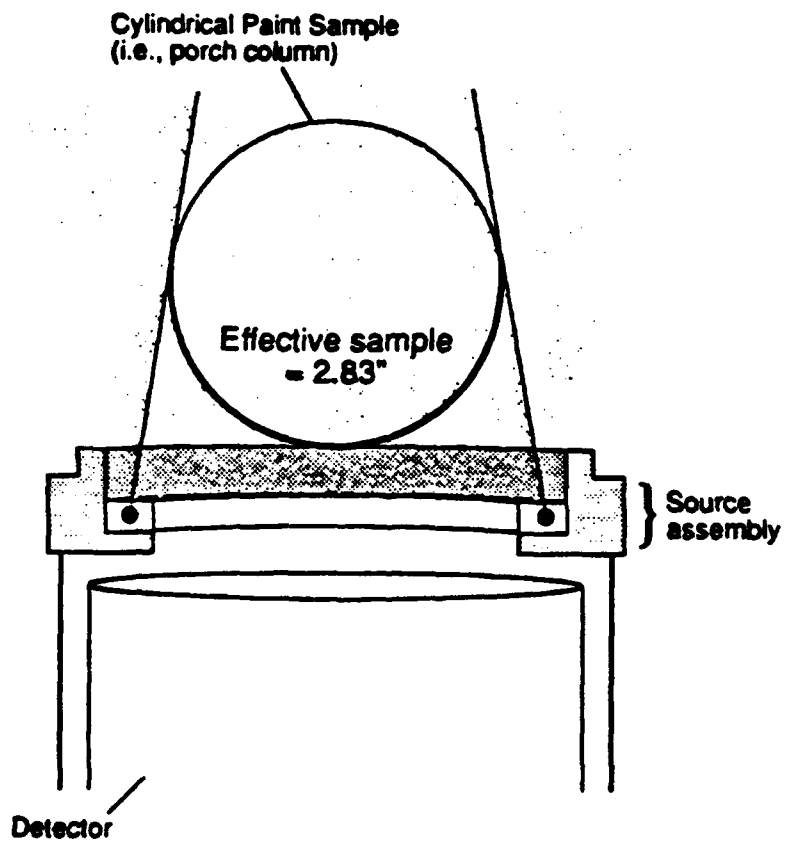
Figure 6. XRF Measurement of Backrail.

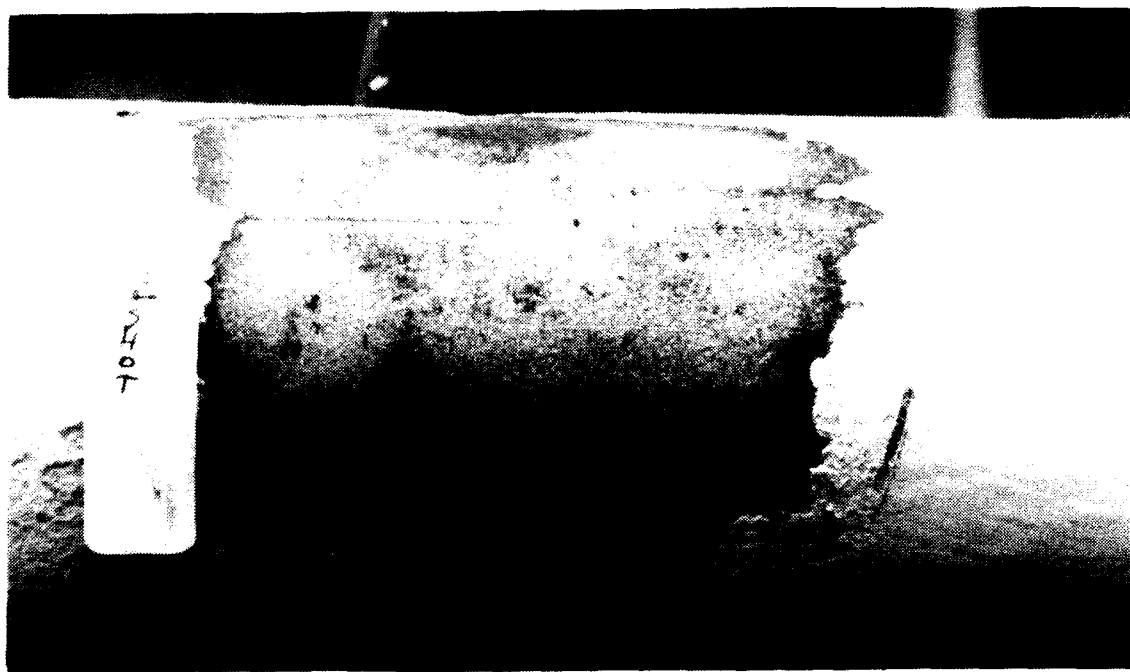
Figure 10. Vacuum Abrasive Cleaned Steel Column, Steel Shot.

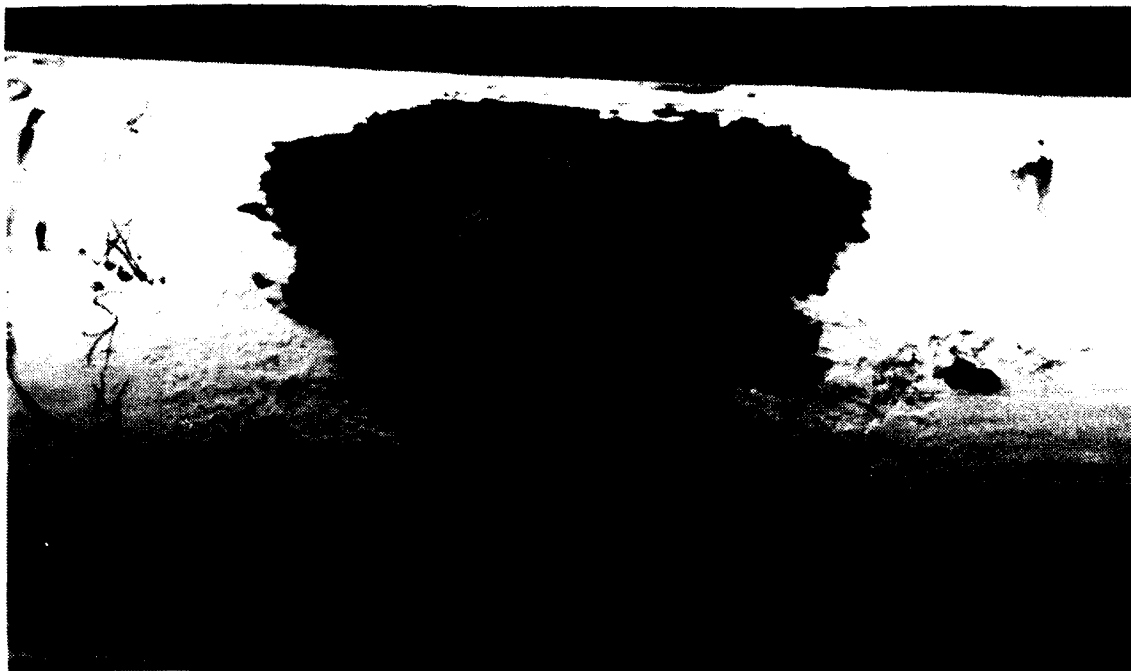
Figure 11. Vacuum Abrasive Cleaned Steel Column, Armex.

Armex is too soft even when mixed with five percent Starblast and requires much more air pressure than the test units could accommodate. Residual paint can be observed on the incompletely cleaned surface prepared with Armex (Figure 11). The surface profile was 0.5 mil. Possibly, the acid neutralizing (basic) properties of sodium bicarbonate could effectively neutralize acidic chemical paint strippers when mixed with a medium such as Starblast and could serve as a post-cleaning/neutralizing step.

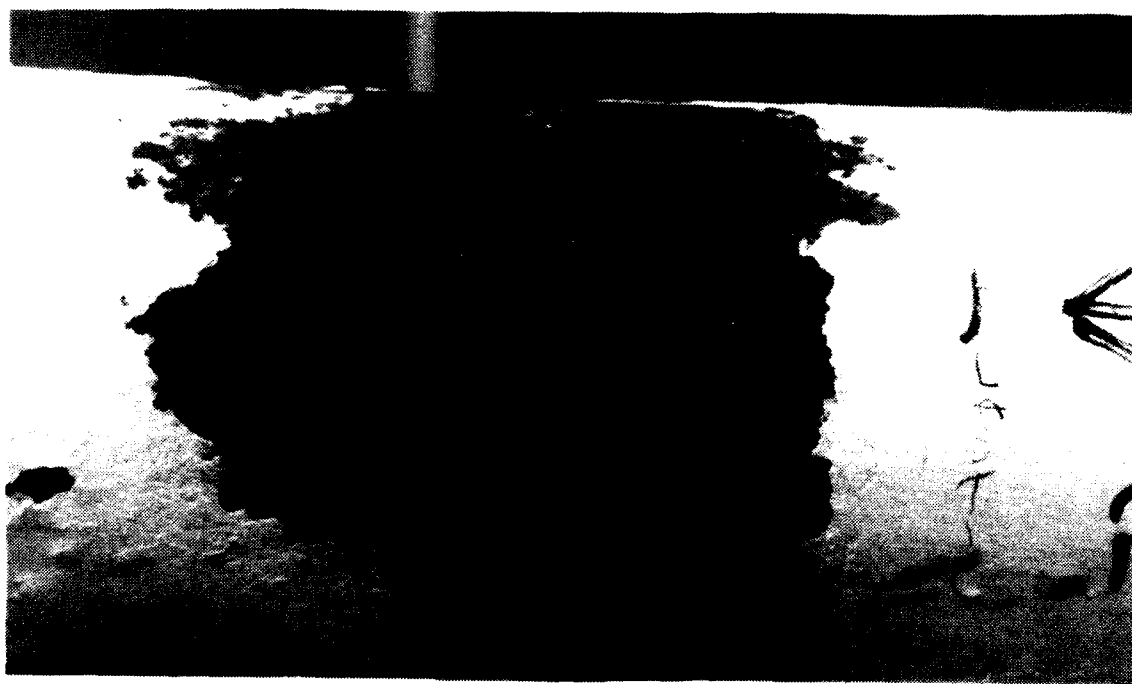
Figure 12. Vacuum Abrasive Cleaned Steel Column, Solidstrip.

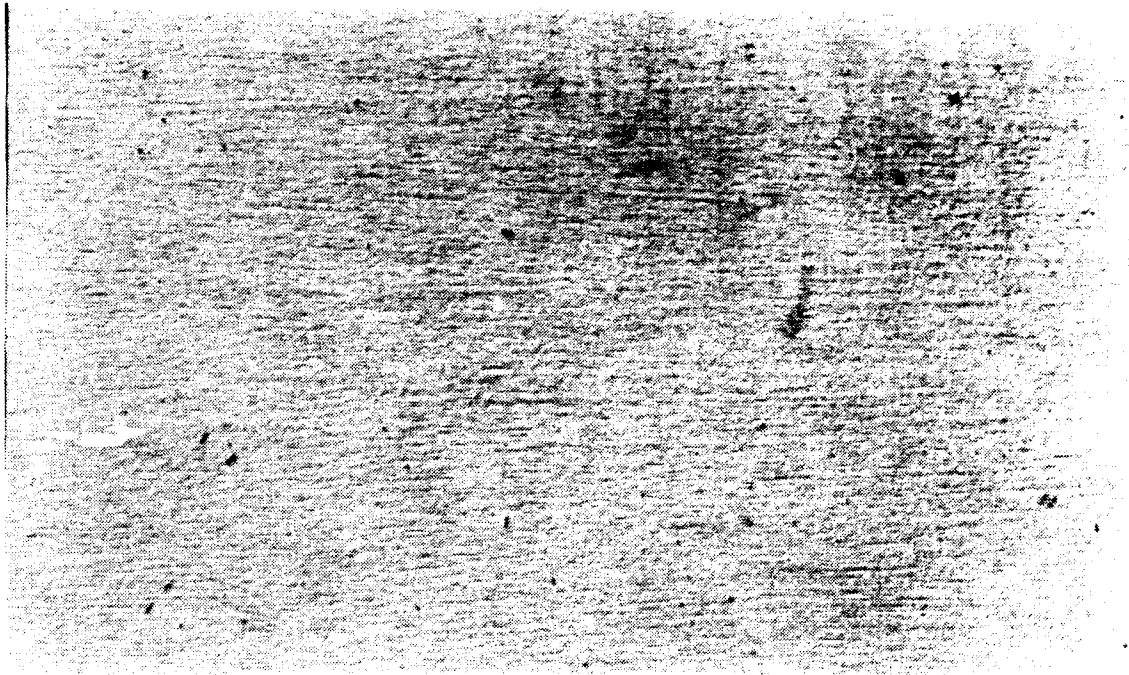
Figure 14. Untreated, Painted Particle Board.

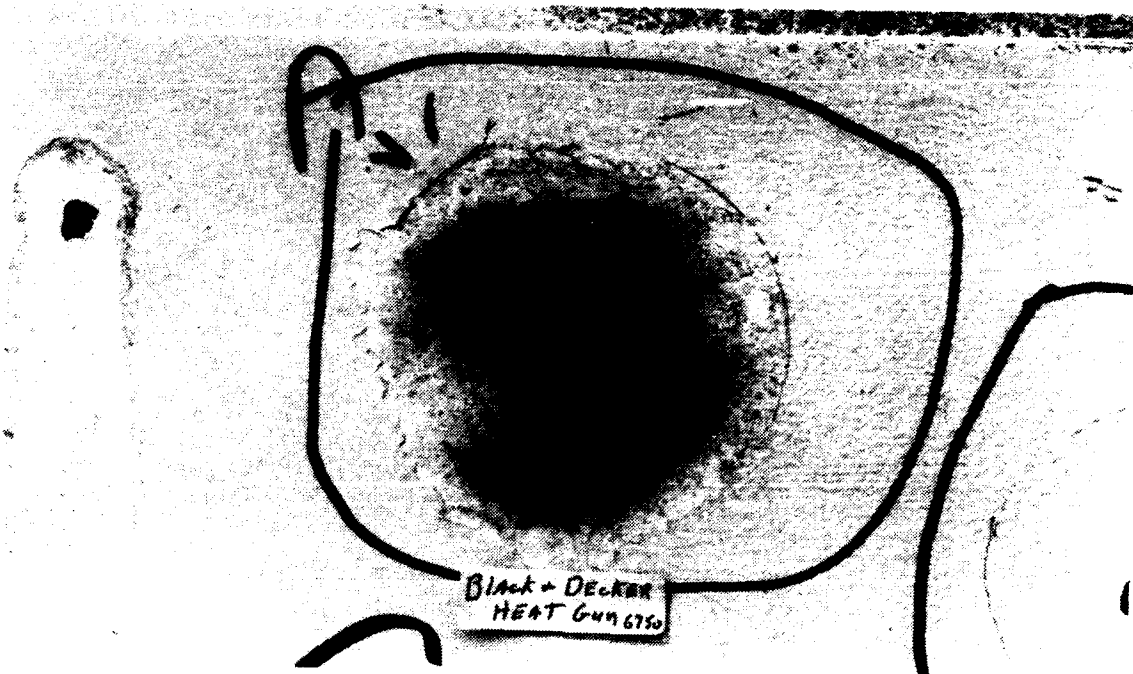
Figure 15. Black & Decker Heat Gun Blistered Particle Board.

Tests for "time to reach blister temperature" were performed to determine the relative speed of paint removal. These tests were performed because it was observed that the paint was removed at the "blister temperature." In each case, the paint consisted of an alkyd resin binder on painted metal and wood surfaces. A calibrated thermocouple attached to a unit with a digital temperature scale was placed directly on the surface. The temperature and time were recorded when the paint blistered. The results follow:

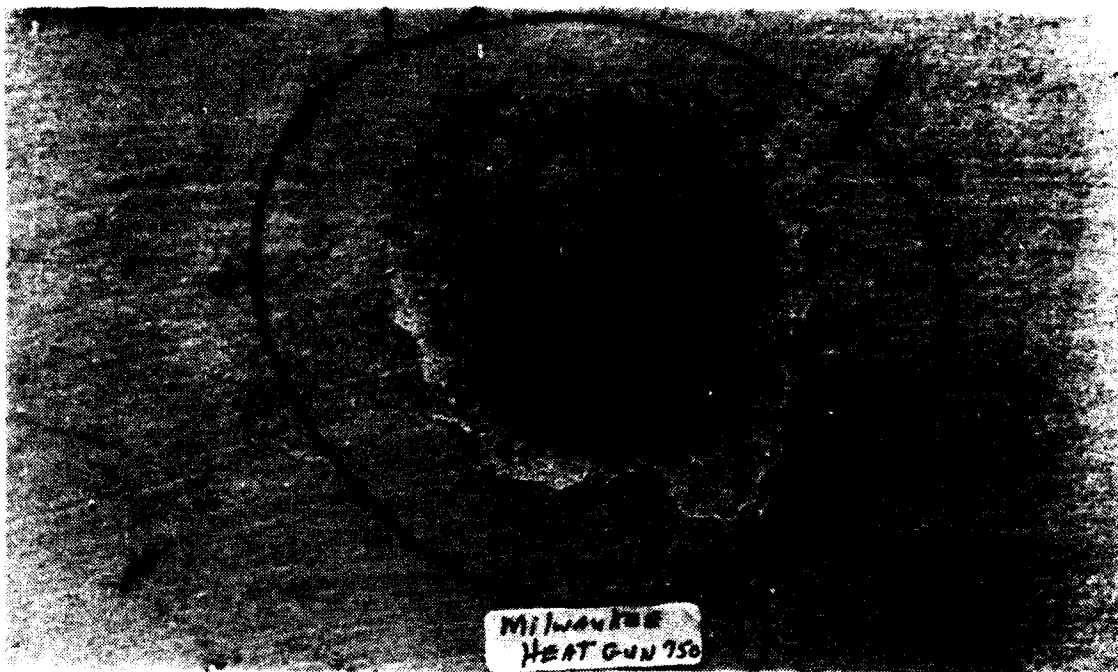
Figure 16. Milwaukee Heat Gun Blistered Particle Board.

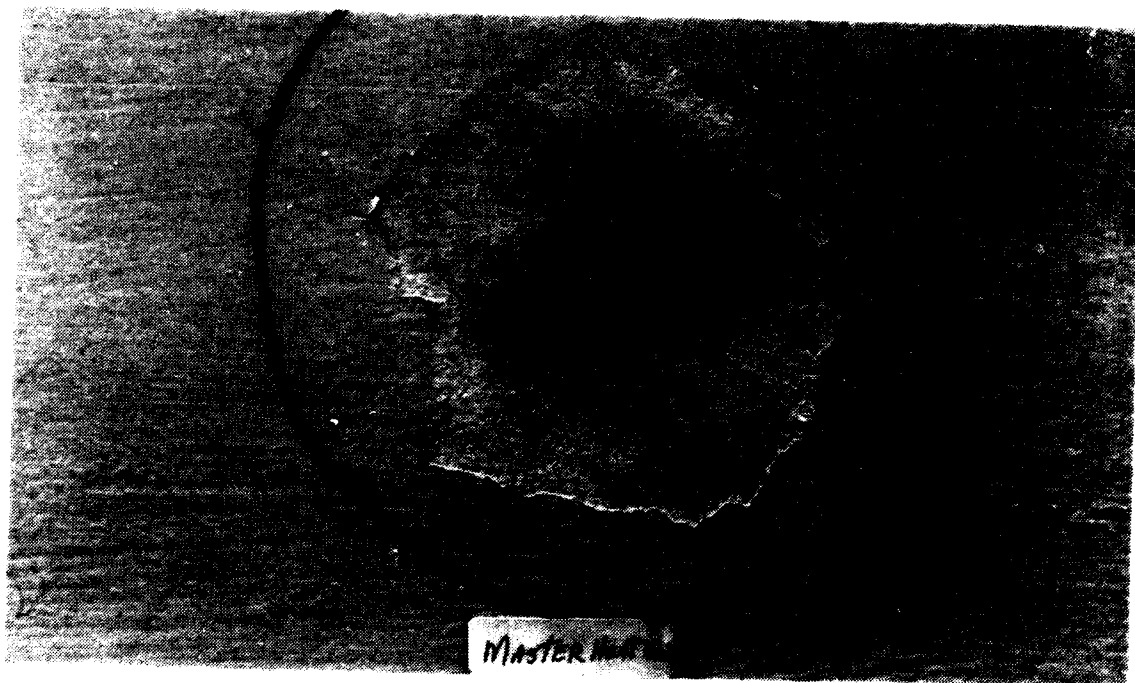
Figure 17. Master Heat Gun Blistered Particle Board.

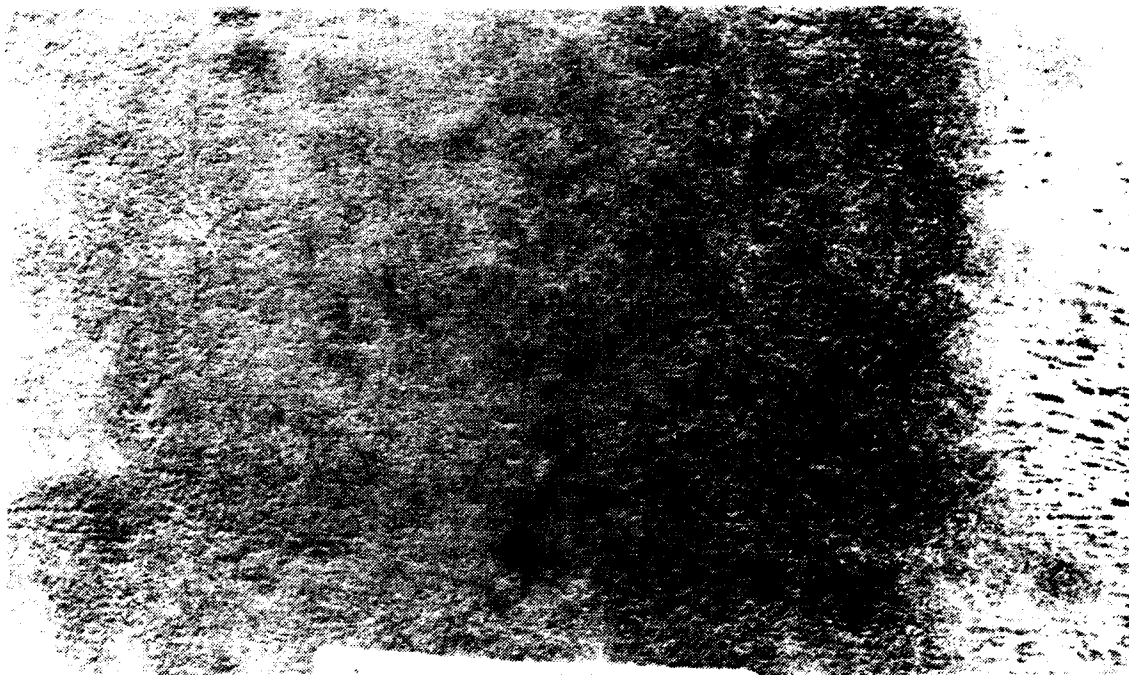
Figure 23. Post-Abrasive Cleaning of Master Heat Gun Cleaned Particle Board.

A combination of heat gun removal of paint followed by "light" vacuum abrasive cleaning is faster than the vacuum abrasive method alone. The removal rate of the combined method is significantly higher for both wood and metal substrates. The advantage of using the composite method is faster removal of paint while rendering a lead-free substrate, which cannot be maintained consistently with heat guns alone. The efficiency of light abrasive cleaning after heat gun treatment of particle board can be seen in photographs taken after vacuum abrasive cleaning. Figures 21 (Black & Decker), 22 (Milwaukee), and 23 (Master) show the vacuum abrasive cleaned test patches of Figures 18 through 20. From these photographs, it can be seen that the surfaces are free from paint, smooth without serious roughness, and that light sanding would render them ready for painting. The slightly charred areas resulted from heat gun cleaning.
